Contract #: 04-0120F4Cty: SF/ALA Rte: 80 PM: 13.2/13.9File #: 99.28**WELDING INSPECTION REPORT****Resident Engineer:**Siegenthaler, Peter**Address:** 333 Burma Road**City:** Oakland, CA 94607**Report No:** WIR-025417**Date Inspected:** 04-Jul-2011**Project Name:** SAS Superstructure**OSM Arrival Time:** 1500**Prime Contractor:** American Bridge/Fluor Enterprises, a JV**OSM Departure Time:** 300**Contractor:** Zhenhua Port Machinery Company, Ltd (ZPMC) Changxing Island **Location:** Shanghai, China

OBG 13AW

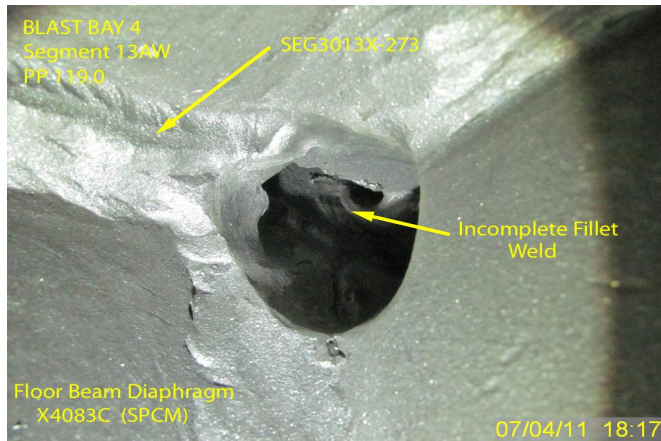
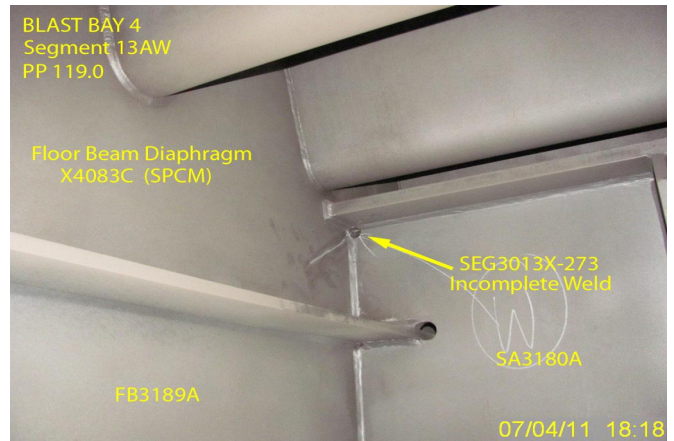
During the Quality Assurance Inspection of Visual testing (VT) of Post blast inspection of Floor beam welds at PP119 of the OBG 13AW [CB Side], this Quality Assurance Inspector (QA) discovered the incomplete fillet weld on weld joint identified as SEG3013X-273 located on floor beam diaphragm to SA3180A. The location is marked up for weld repair and was recorded on a weld map for future repair. For further information, please see the attached pictures below:
